A Flight Tests the Standard

Evaluation of Cirrus B

by RICHARD E. JOHNSON

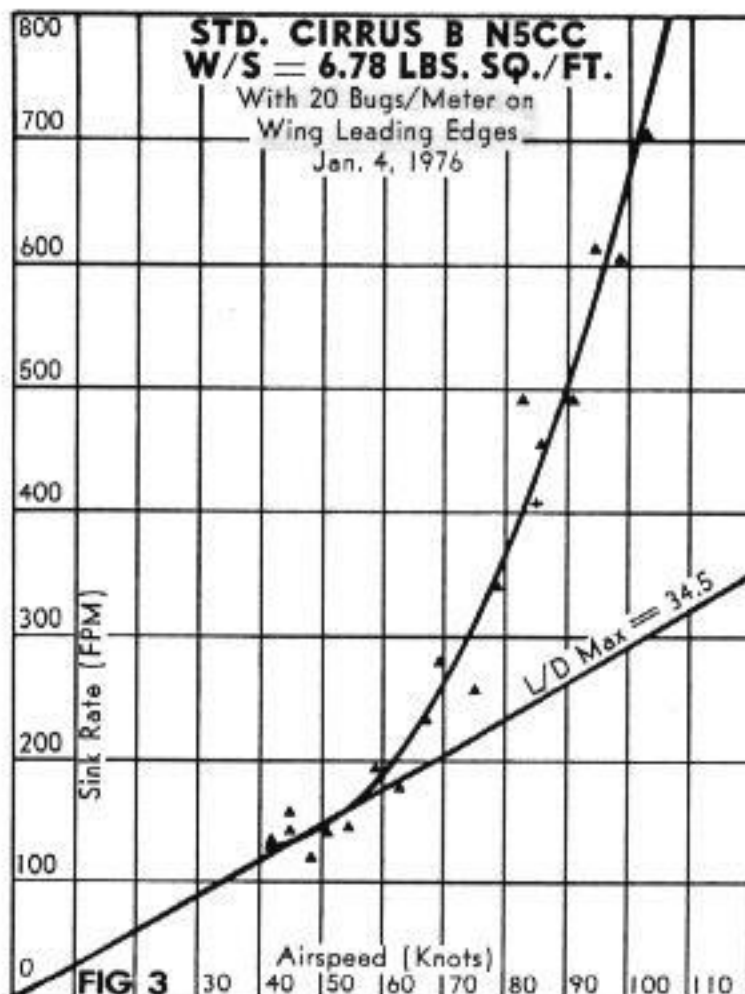
This bug installation was fairly severe by U.S.A. standards, but the Standard *Cirrus* performed surprisingly well thus encumbered. Fig. 3 shows the measured "buggy" polar which indicates only a four percent decrease in L/D max. At 90 knots the "bugs" increase the sinking speed by about 14 percent. Next month's report will show a much more severe effect on the *Nimbus II* performance polar.

Almost all thermal soaring includes sharing one's air currents with various small flying insects. Though not very numerous in the arid desert regions, their numbers and degrading aerodynamic effects through impacting and roughing the wing leading edges can be a significant factor to the sailplane's performance polar when flying in more moist regions. My limited flying in Germany indicated insect roughing posed a more significant effect there than anywhere in the U.S.A., and I have been informed that it is even worse in Finland. For this reason a flight polar measurement of the *Cirrus B* was performed with a pattern of simulated impacted insects stuck along the wing leading edges. These simulated insects were actually little squares of silver duct tape, about .01 inches thick and measuring about .20 inches on the sides. A pattern was used where one "insect" was placed each six inches directly on the wing leading edges, another row in between about one inch above the leading edge, and a third row also in between and about one-half inch below the leading edge.
